# Corrosion threats and strategy to secure mechanical integrity of Dung Quat refinery

Binh Son Refining and Petrochemical JSC

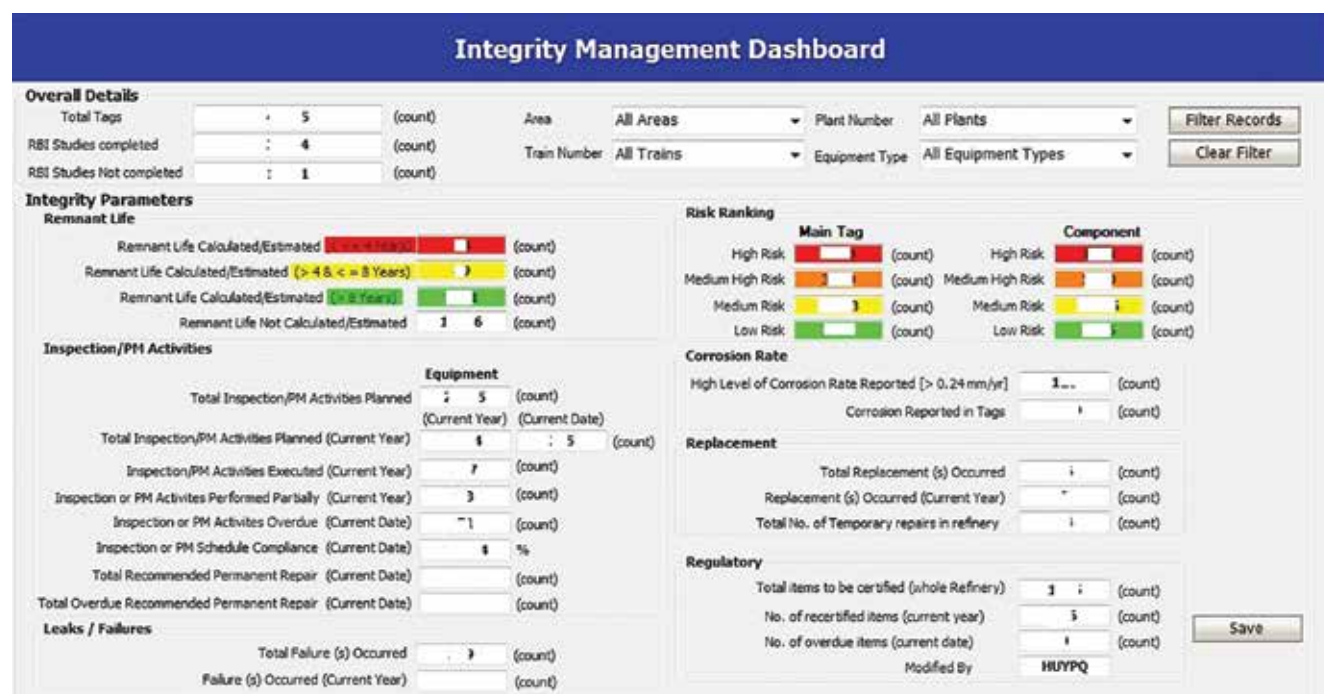
Figure 3. CIMS dashboard window.

Corrosion and inspection management system (CIMS) is the essential tool for managing inspection plan of a very large quantity of stationary equipment and pipelines installed in the plant. BSR has fully utilised a dedicated CIMS software as the central tool for corrosion and inspection management in accordance with API RP 580 [4]. All mechanical assets are registered into the system together with their related engineering data. Then, on the basis of risk-based inspection study, detailed inspection plans will be developed for each of the equipment or piping system. A very simple workflow will be configured to the system allowing convenient usage by inspection engineers. Subsequent inspection data will be uploaded into CIMS system for detailed analysis using software built-in functions. Analysis results will then be used by corrosion engineers for determining next inspection date of the concerned asset.

A mechanical integrity dashboard was additionally

developed by BSR inspectors providing main KPIs such as the number of assets having a remaining lifetime of less than 4 years, re-certification compliance, and inspection schedule compliance rate, etc.
